Challenge in manufacturing high-precision cameras

Axes for sensor positioning

Effects of insufficient sensor alignment

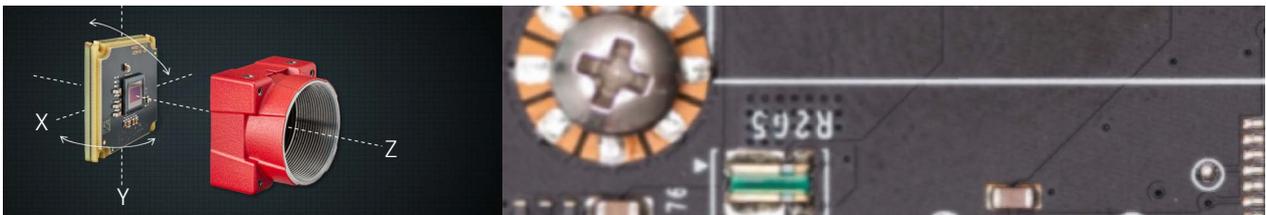
The image has a variance of $90\ \mu\text{m}$ between the highest and lowest horizontal pixel of the sensor measured along the optical axis. This equals a rotation of 0.573 degrees around the Y-Axis. The resulting focus drift blurs the vertical edges

Figure 5: The sensor is tilted to the lens mount

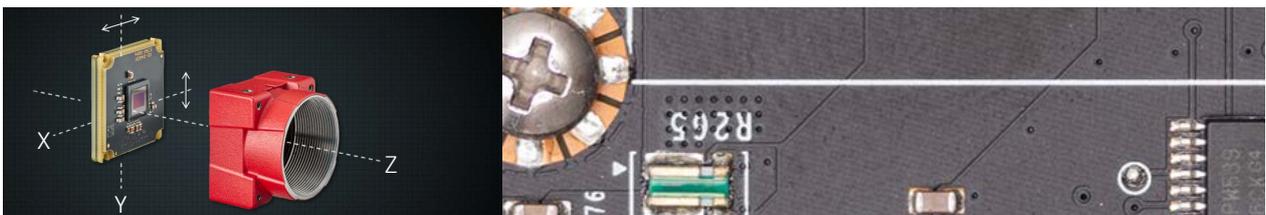
The image is shifted to the right by $200\ \mu\text{m}$ (~ 66 pixels). The screw head is cropped on the left.

Note: Depending on the lens, the sharpness can be different between the image corners. Potential vignetting is shifted out of center as well, which is harder to correct than typical vignetting that is centered.

Figure 7: The sensor is shifted along the X-Axis
